## PHASE I REPORT National Dam Inspection Program

Immel Dam

26 April 1978 (visual inspection)

Inspection Team - GAI Consultants, Inc.  
570 Beatty Road  
Monroeville, Pennsylvania 15146

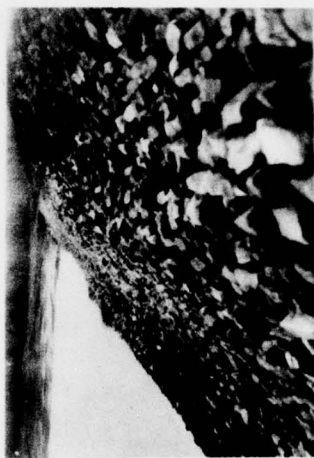
PHOTOGRAPH 2     Photograph 2 shows the southern embankment as it appeared in 1935. Note the bulge evident over entire width of the embankment.

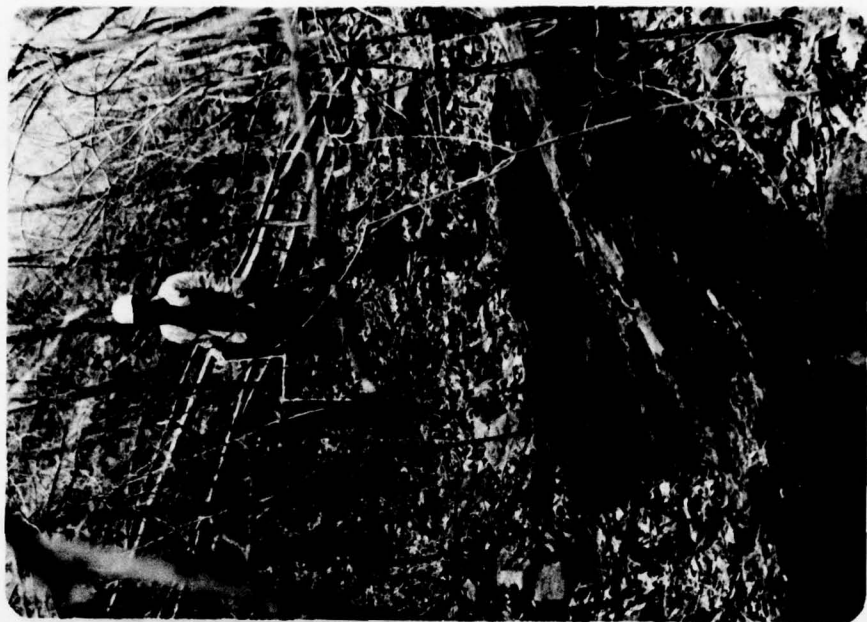
PHOTOGRAPH 4     A view of the control pipes located at the toe of the southern embankment which are used to regulate incoming water which is gravity fed from Sewickley Creek Reservoir.

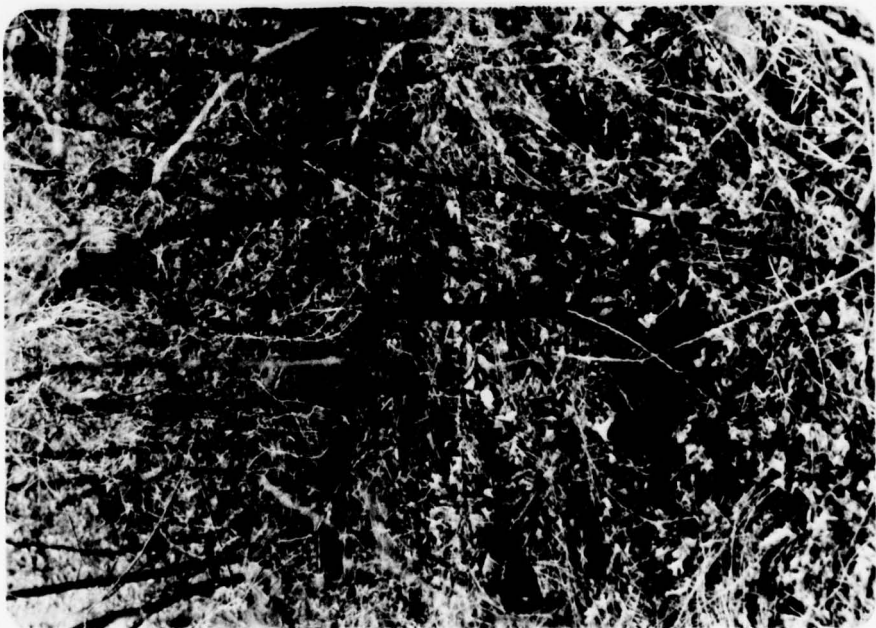
PHOTOGRAPH 5    A view looking downstream from the crest of the southern embankment showing one of many standpipes found throughout the Immel embankment. None of the standpipes was operable. They were probably installed in the early 1920's.

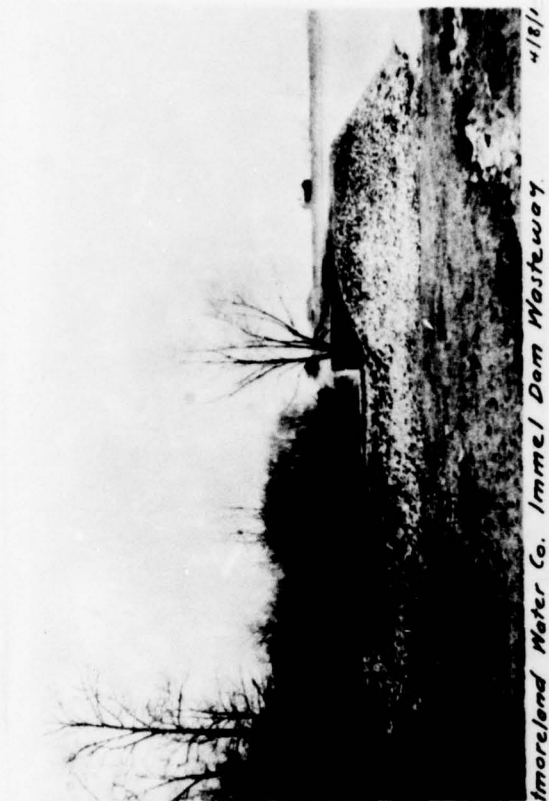
PHOTOGRAPH 8    Photograph 8 is a view of the approach to the spillway of Immel Reservoir as it appeared in April 1915.

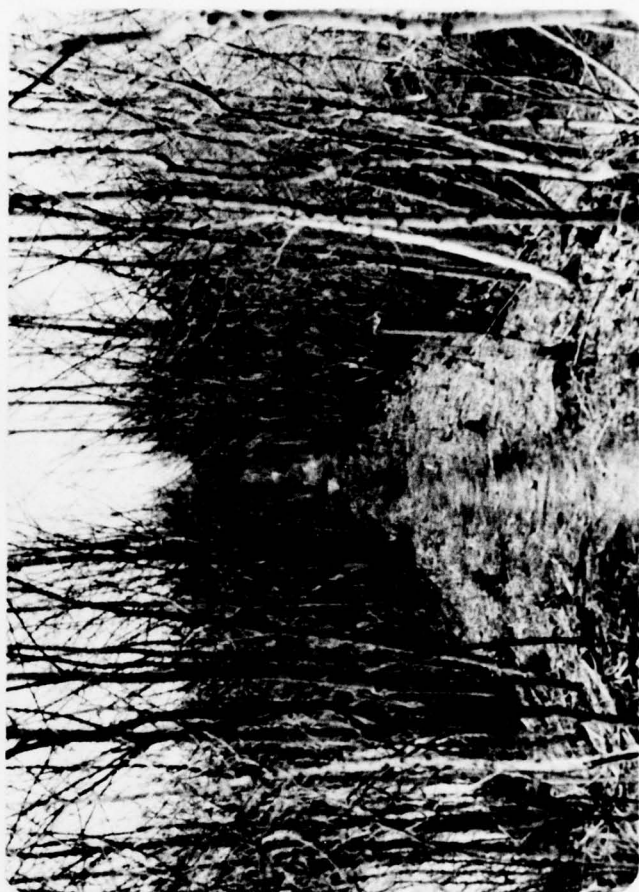
PHOTOGRAPH 13 View of the crest of the northern embankment of Immel Reservoir.

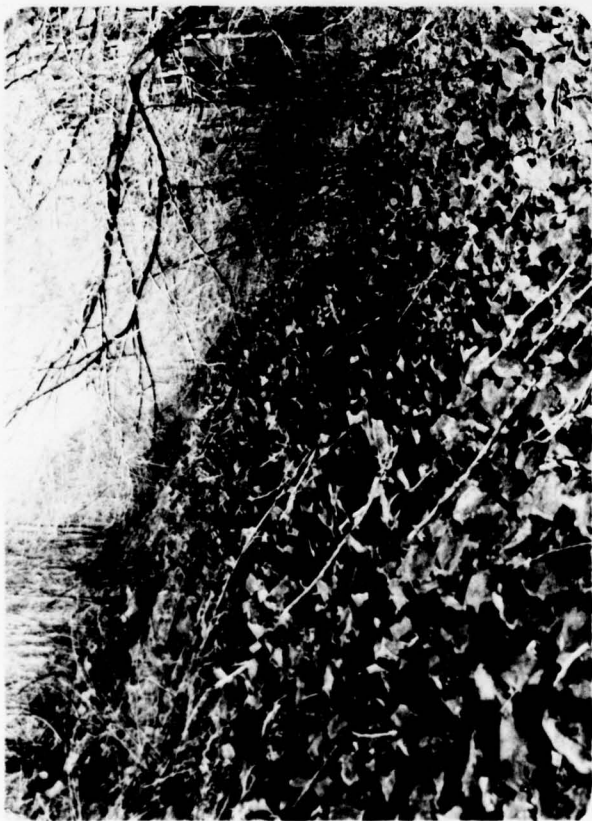
PHOTOGRAPH 14 View of the downstream portion of the northern embankment. Again, one can easily see and pick out the transition between the old dam that is the gray riprap seen in the foreground and the new portion of the embankment which is heavily vegetated. Also note that there are many bulges shown in this photograph. This is typical of the upstream and downstream portions of the embankment.

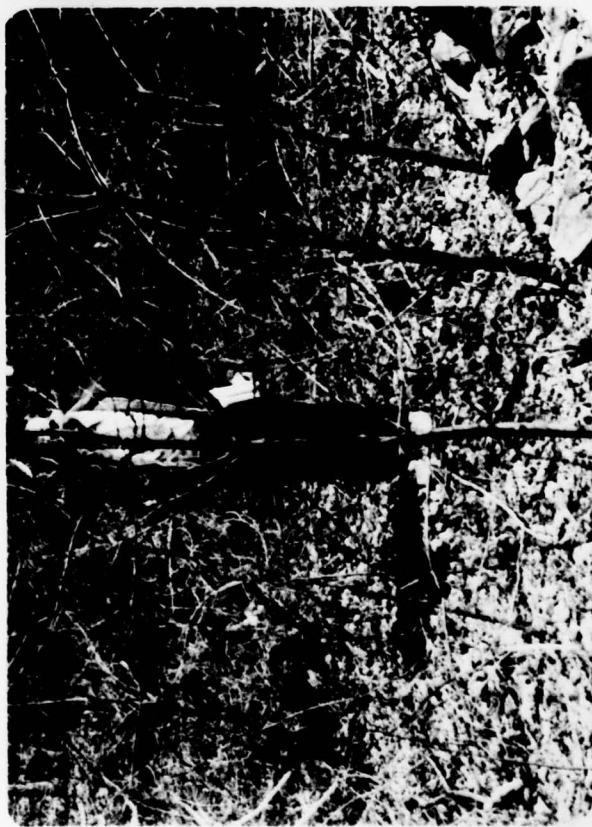
PHOTOGRAPH 16 A view of the control valves for the 16-inch steel pipe which feeds water from Armel to Immel Reservoir. This one, however, is located in the pipe, passes through the northern embankment, and according to a representative of the Westmoreland Municipal Authority, this particular valve has been closed for approximately eight years.

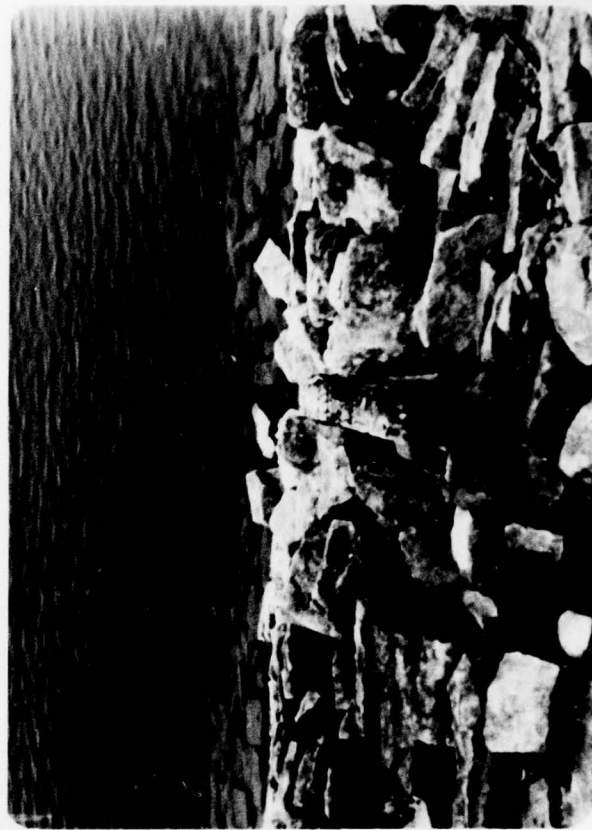
PHOTOGRAPH 17 View of the staff gauge located near the western portion of the north embankment. The gauge is reportedly read weekly and is marked in feet and inches. Bulges, such as the one shown on this photograph, are present throughout the north embankment.

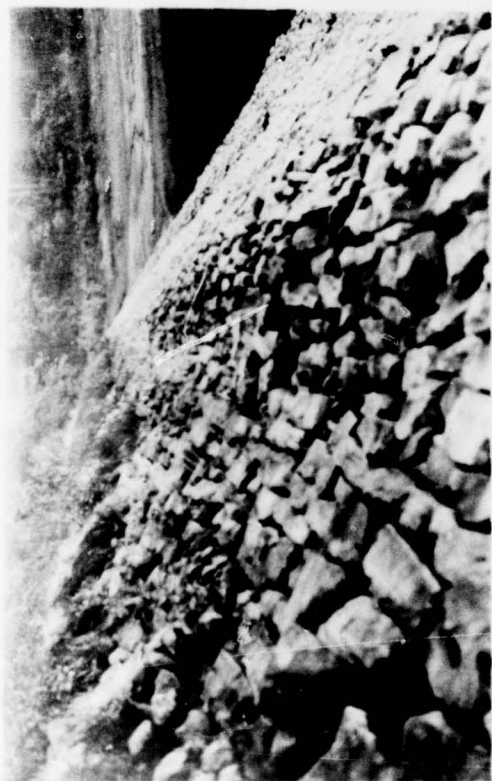
PHOTOGRAPH 18    Photograph 18 shows some of the bulges in the north embankment as they appeared in 1946.

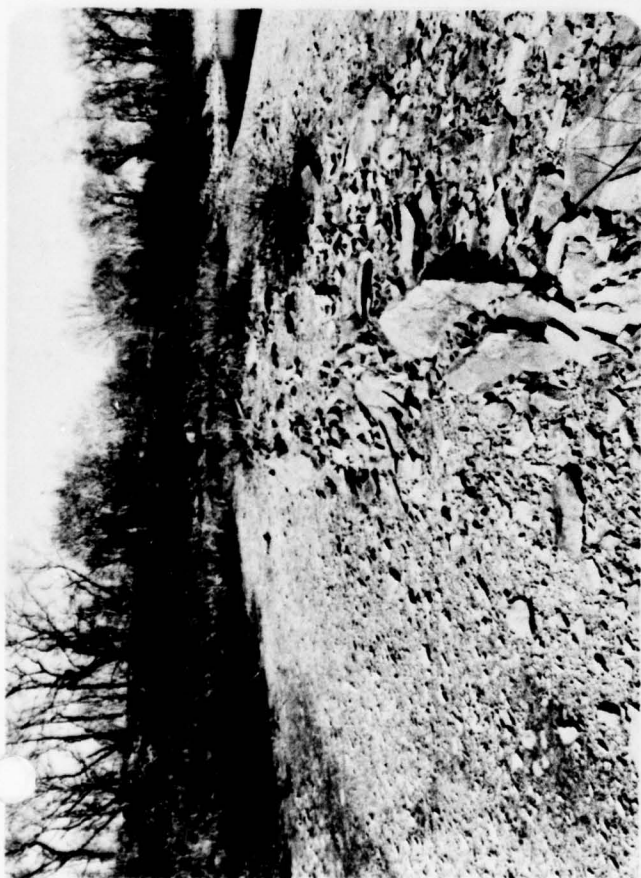
PHOTOGRAPH 22 View of an outcrop within the reservoir near the northwest corner of the embankment. The sandstone outcroppings are exposed over the entire length of the western embankment. This is significant when one considers that the foundation near the western and northern portions of the western embankment has a history of seepage.

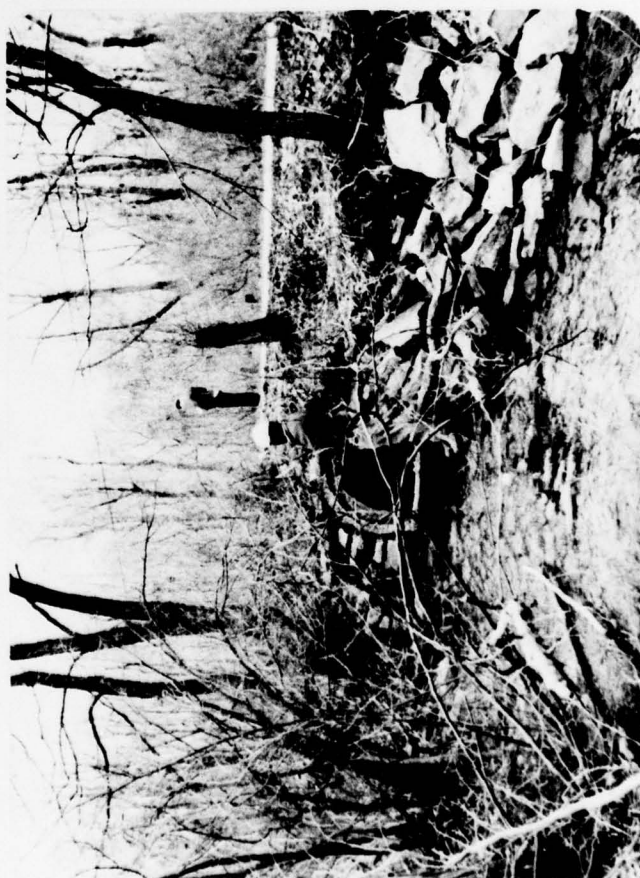
PHOTOGRAPH 23 A view showing some seepage near the northwestern corner of the Immel Reservoir embankment. The northern portion of the western embankment is visible in the background of the photograph. The amount of seepage was very small at the time of inspection, however, the seepage was issuing from approximately the same elevation as the water level in Immel Reservoir at that time. It is possible that seepage is considerably greater when the water level is higher in Immel Reservoir.

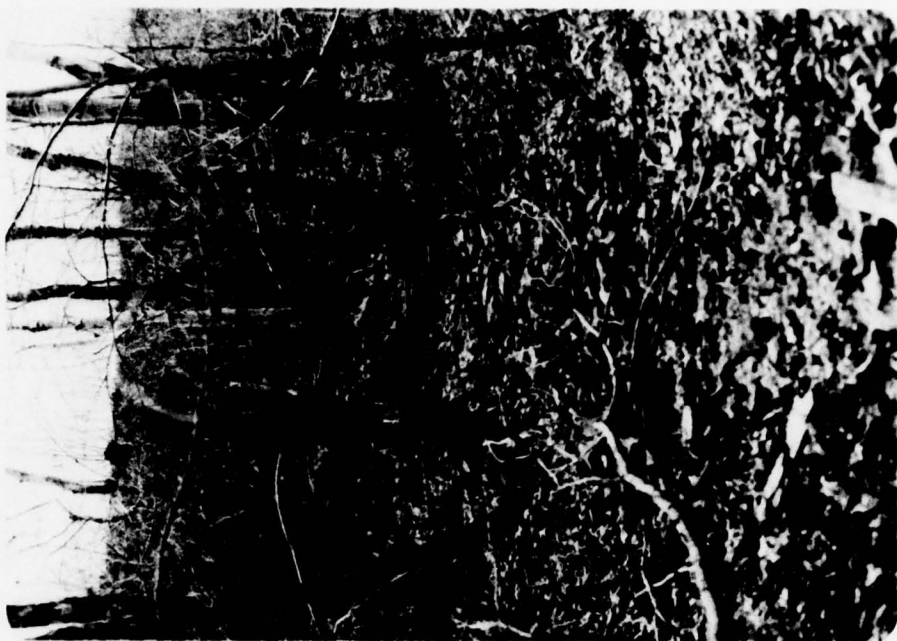
PHOTOGRAPH 24 This is a view of the first downstream improvement from the northern portion of the Immel Reservoir embankment. The 36-inch RCP shown in the photograph passes beneath a paved road approximately one mile downstream of the reservoir.
